### Lundin Gold Reports 204.26 g/t Au over 3.05 Metres at Bonza Sur; Quebrada Dorada Discovery Extends Gold Epithermal Trend to 8 km

Lundin Gold Inc. (TSX: LUG) (Nasdaq Stockholm: LUG) (OTCQX: LUGDF) (“Lundin Gold” or the “Company”) is pleased to report results from its ongoing near-mine exploration drilling programs at the Fruta del Norte (“FDN”) gold mine in southeast Ecuador.

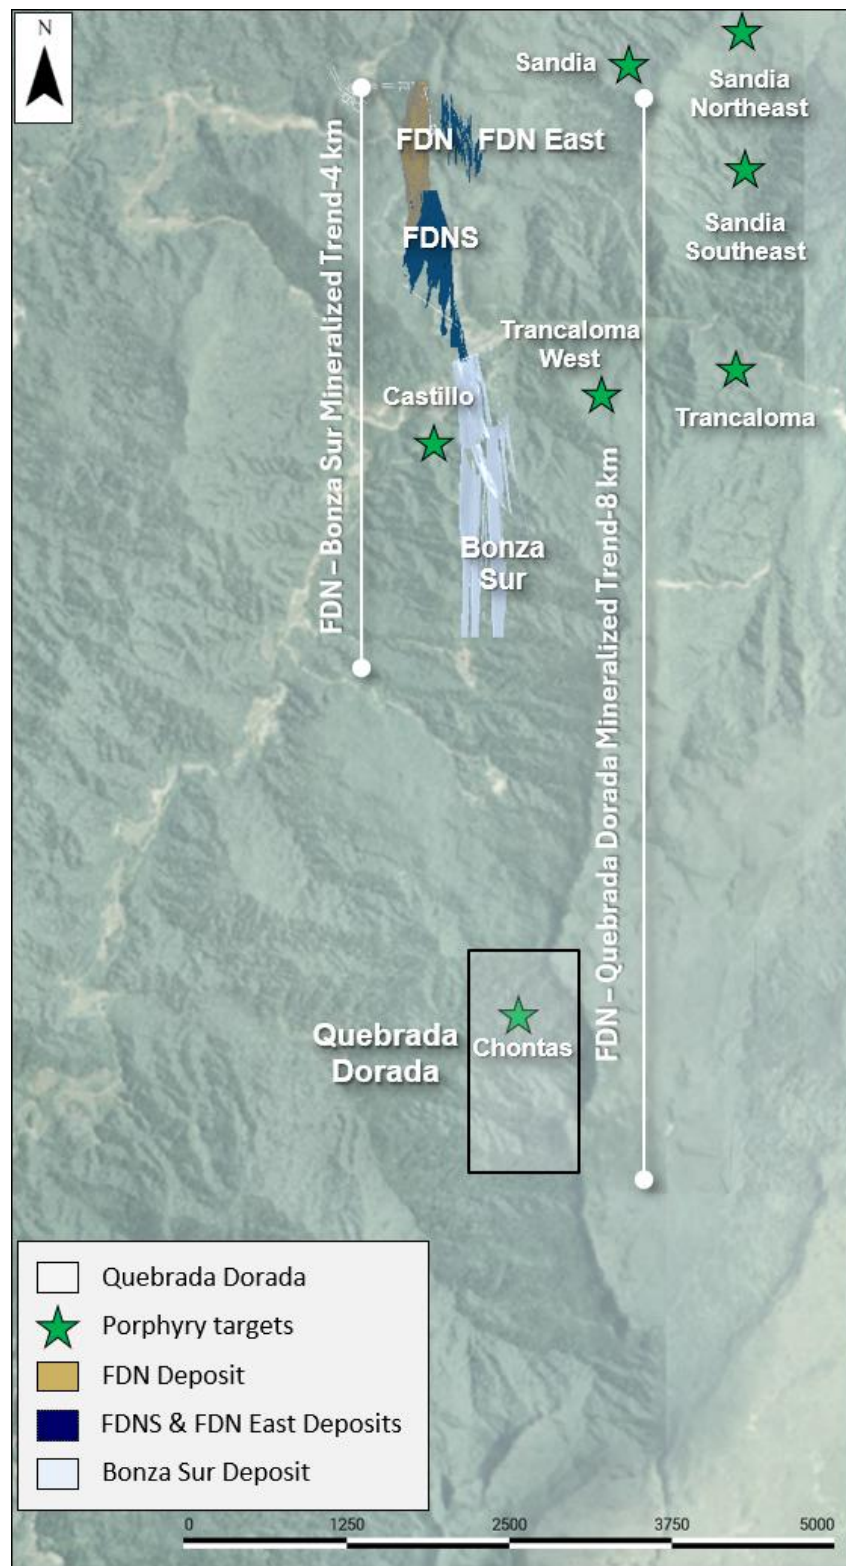
**Figure 1:** Map showing the FDN District mineral footprint with the FDN, FDNS, FDN East, Bonza Sur deposits and Quebrada Dorada discovery.

Over the past several years, Fruta del Norte has emerged as a globally significant mineral district containing multiple identified epithermal gold systems and copper-gold porphyries. The Company's exploration strategy has so far resulted in the discoveries of the Fruta del Norte South (FDNS), Fruta del Norte East (FDN East), and Bonza Sur deposits and has defined a continuous mineralized trend extending for more than four kilometres between FDN (in the north) to Bonza Sur (in the south). The discovery of a new epithermal gold system at Quebrada Dorada further extends the gold mineralized trend to eight kilometres (Figures 1 and 3).

Located on the eastern side of the East fault approximately two kilometres to the south of Bonza Sur, Quebrada Dorada represents the discovery of an entirely new epithermal vein system on the FDN property (Figures 1, 3 and 4).

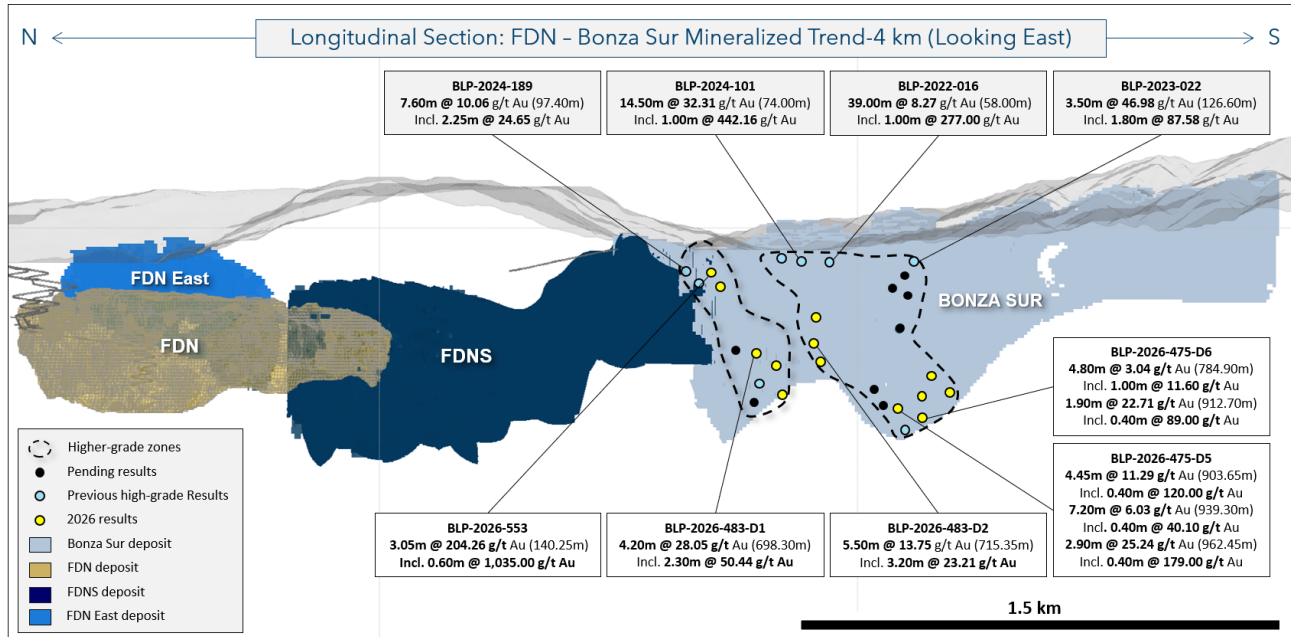
**Figure 2: Longitudinal section showing the FDN-Bonza Sur epithermal trend with new and previously reported exploration drilling results at the Bonza Sur deposit.**

Discovered by testing a surface geochemical anomaly south of FDNS, Bonza Sur is a large, shallow epithermal system that has been defined with wide-spaced drilling along two kilometres of strike. Mineralization at Bonza Sur extends to surface and consists of disseminated mineralization with higher-grade zones occurring within the broader mineralized envelope (Figure 2).

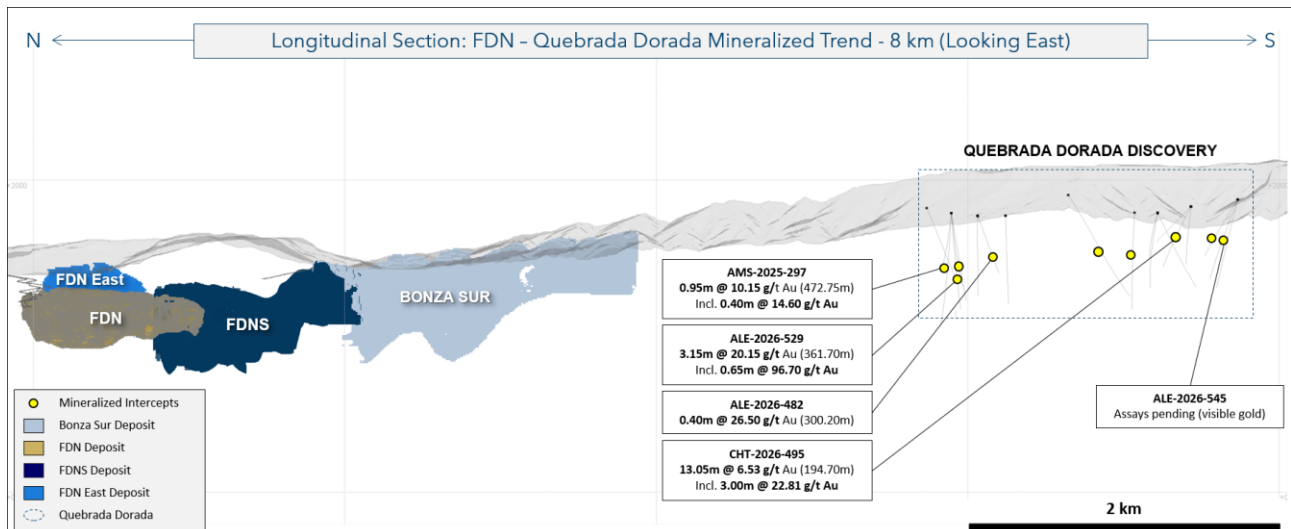
**Figure 3: Longitudinal section showing the FDN-Quebrada Dorada epithermal trend with selected exploration drilling results at the Quebrada Dorada discovery.**

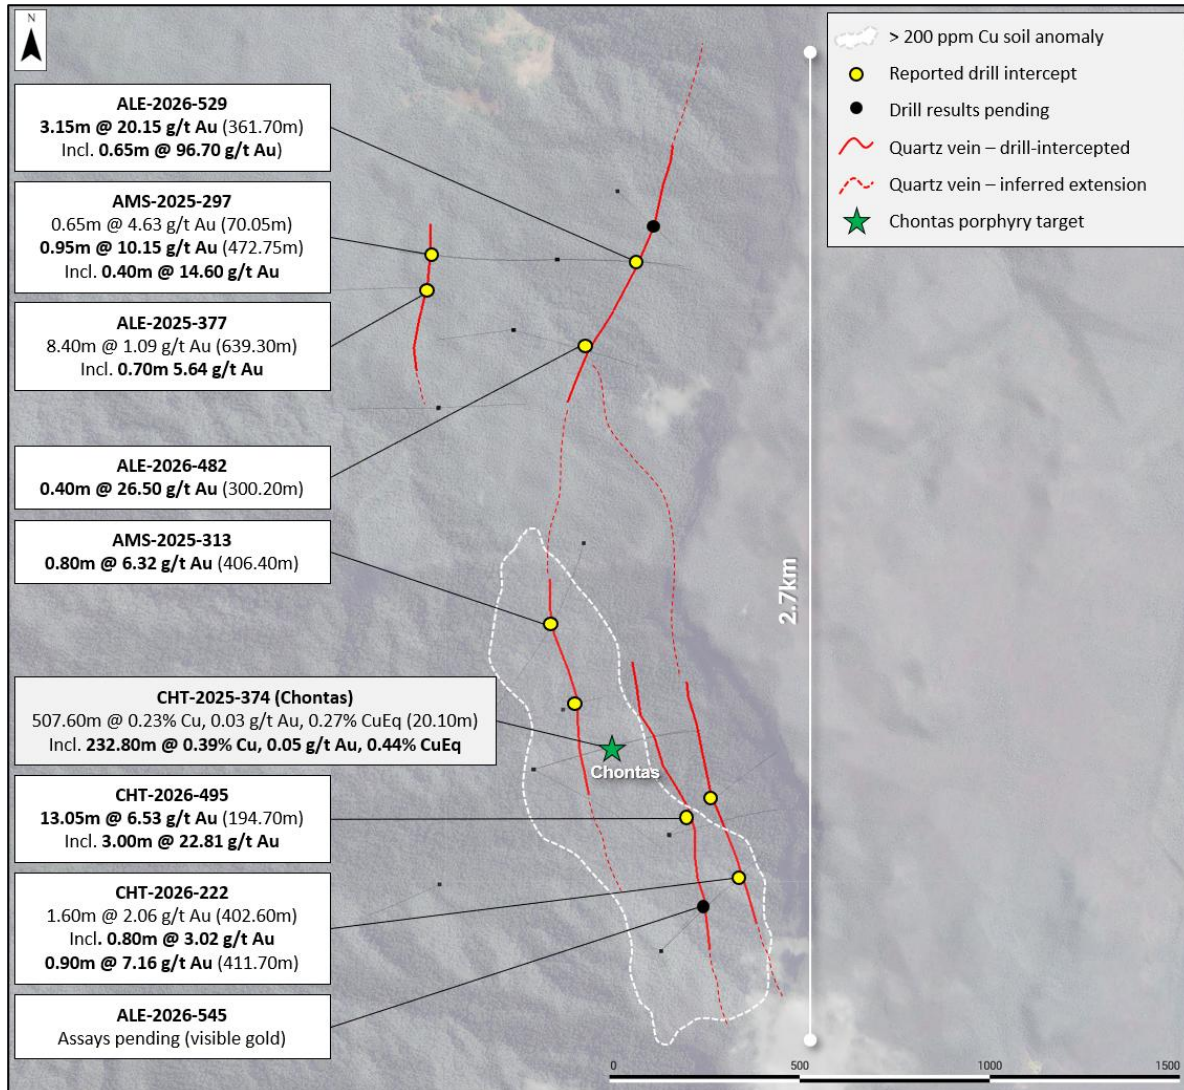
**Figure 4: Map showing the Quebrada Dorada discovery with selected exploration drilling results.**

The drilling program at Quebrada Dorada has advanced rapidly, with the mineralized footprint currently defined over approximately 2.7 kilometres from north to south (Figure 4). Gold mineralization is hosted by multiple generations of subparallel quartz-chalcedony veins with local hydrothermal breccias and stockworks, native gold, and minor sulphides including galena and sphalerite. The system remains sparsely tested, and drilling is now focused on following up these initial results. Two rigs are currently drilling at Quebrada Dorada. Results received to date are summarized in Tables 2 and 3.
